Manhole Covers Ireland

T Range Hinged & Locked D400 C & F

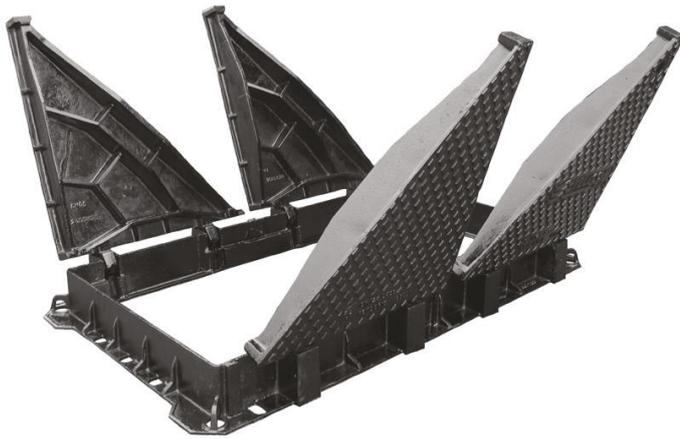
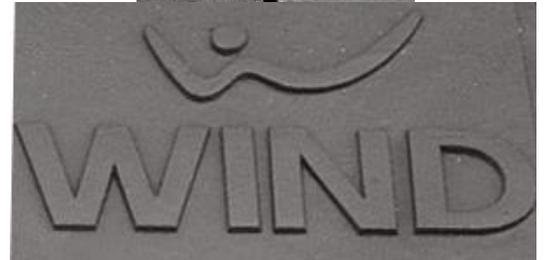
It is realized in a single cast, it can be opened by rectangular or triangular section covers with double hinges, with the aim of having free access to 2/3 sides. Externally, the outside border is flanged in order to optimise its hold in the cement and it has specific holes for the insertion of the anchoring bolts.

It comes triangular in shape, it is hinged to the frame with top opening of 110°. At 90° it assumes the automatic safety blocking position and can be removed without disassembling the hinge. This method allows partial and sequential opening with a coupling system placed on the edges, which reduces the infiltration of water. The master half cover section is provided with a stainless steel lock, operable using a special shaped key which guarantees safety and prevents the opening of the manhole covers by Unauthorised personnel. Furthermore the key becomes a comfortable handle for opening and closing the cover. The upper surface is designed to be non-skid to allow the complete flow of water and avoid the creation of ice.
